Testing was conducted at Robot City. It was snowing and there was approximately 4 inches of snow on the ground. The average temperature was 20°F (-6°C).

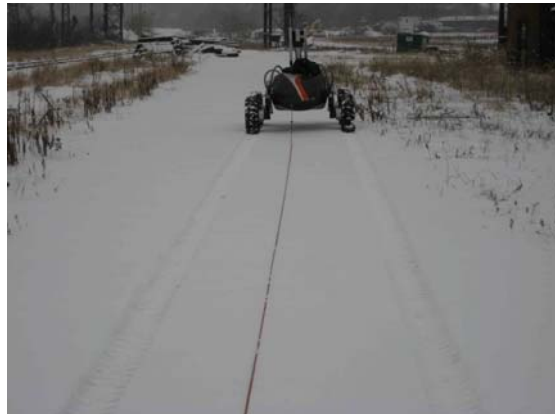
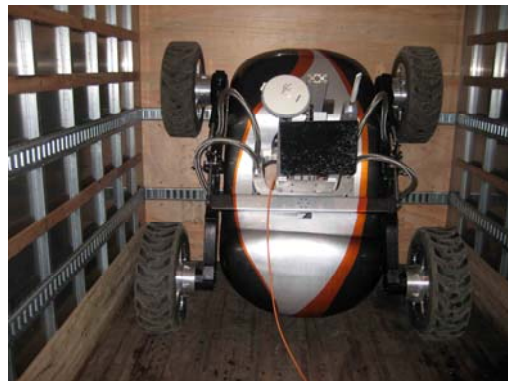
5. Scarab climbed a vertical wall with no trouble.
  - a. The body angle was about 56°.
    - i. Scarab was still stable, we stopped for safety reasons.
